Submarine Cable Update Report

Incident: Stikine Cable 1 (C-Phase)
Failure/Fault Event

Date: 12/9/2019

Robert Siedman, P.E.

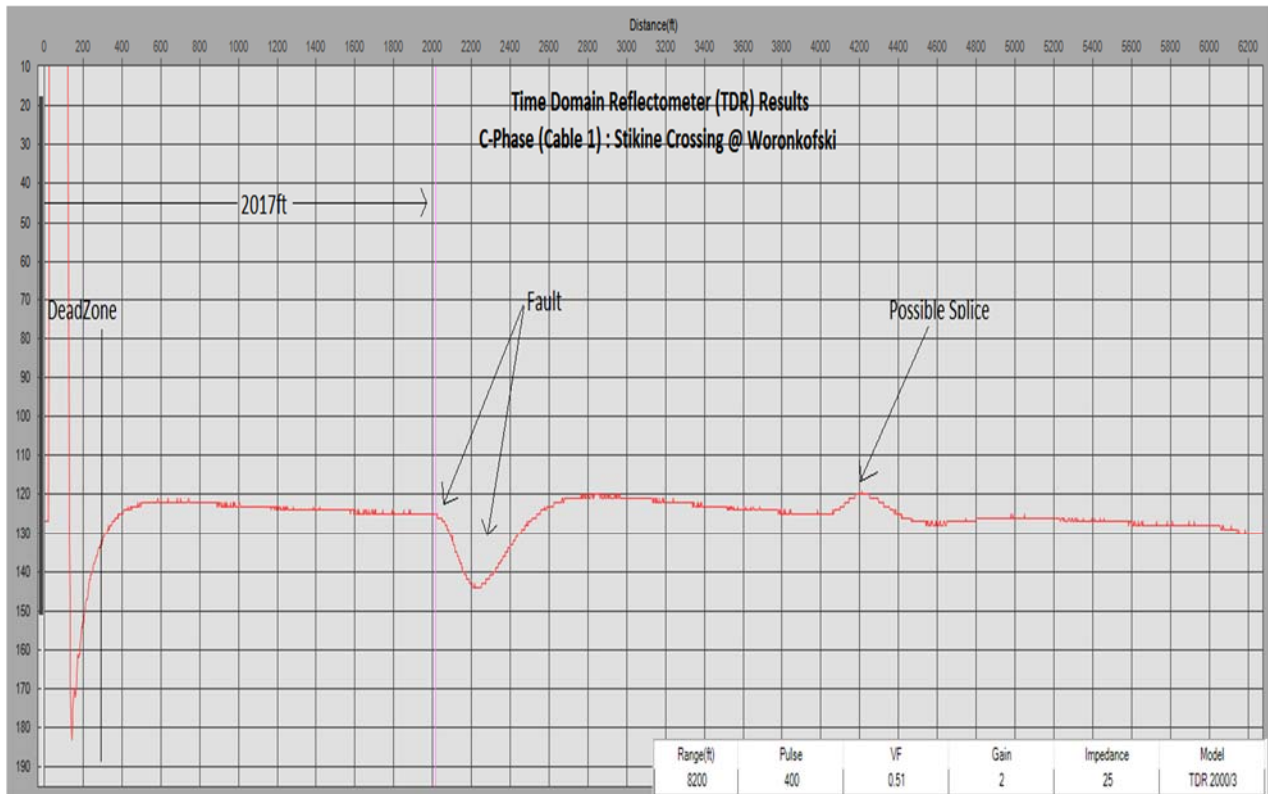
Figure 1: TDR Results

SEAPA performed Time Domain Reflectometer (TDR) tests on October 9 (Figure 1). Test results conclusively indicated that the fault was located approximately **2000 feet** from the Woronkofski marine terminal, in approximately **300-400 feet of water**.

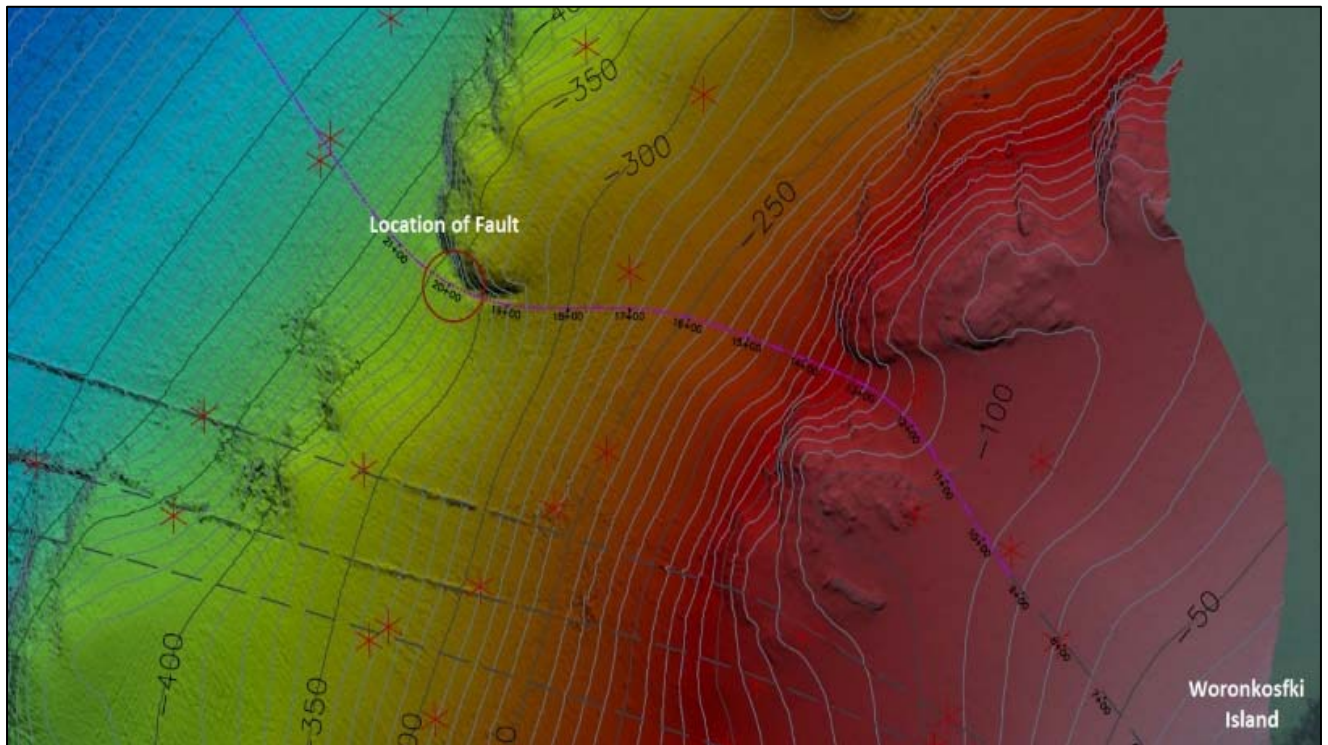
Figure 2: Bathymetric Survey

On October 12, SEAPA contracted a hydrographic survey company (eTrac) to perform bathymetric, side scan and magnetometer surveys. The results of the survey(s) provided existing routing of the Stikine cables to help determine root cause of failure and the path forward for repair or replacement. Figure 2 illustrates the existing location of Cables 1-4 off the shore of Woronkofski Island.

Aside from water ingress and the length of spare cable available to make a repair, another important factor for the success of a repair is the depth of cable burial. From the bathymetric survey data as shown in Figure 2, it is apparent that cables 2-4 are above surface for much of their lay profile. Cable 1 however, does not appear in the bathymetric survey, which indicates that it is buried below the subsea floor. As the depth of burial increases, the risk of damaging the cable during retrieval due to excessive forces also increases. In general, depths of over 3ft (under silt) are risky. SEAPA has initiated the following to further identify risk of repair with regard to water ingress and depth of burial:

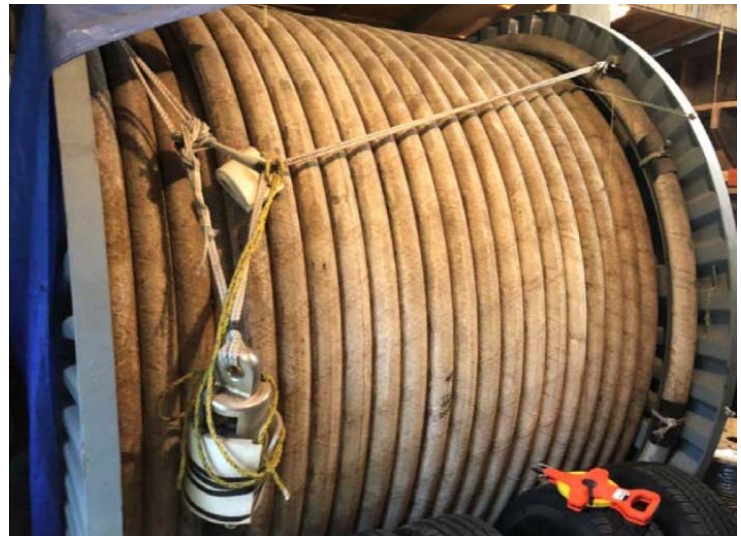
Figure 3: 2000ft reel of spare submarine cable

A number of factors correlate to the success of a repair on the Stikine submarine cable. The length of damaged cable due to water ingress is a crucial factor due to the limited amount of spare cable that SEAPA has available. Inventory and subsequent field verification indicate that there is approximately 2,000 feet of spare cable on a cable reel located at the Wrangell Switchyard Warehouse. If the amount of damaged cable is greater than 2,000 feet, a repair is likely not possible.

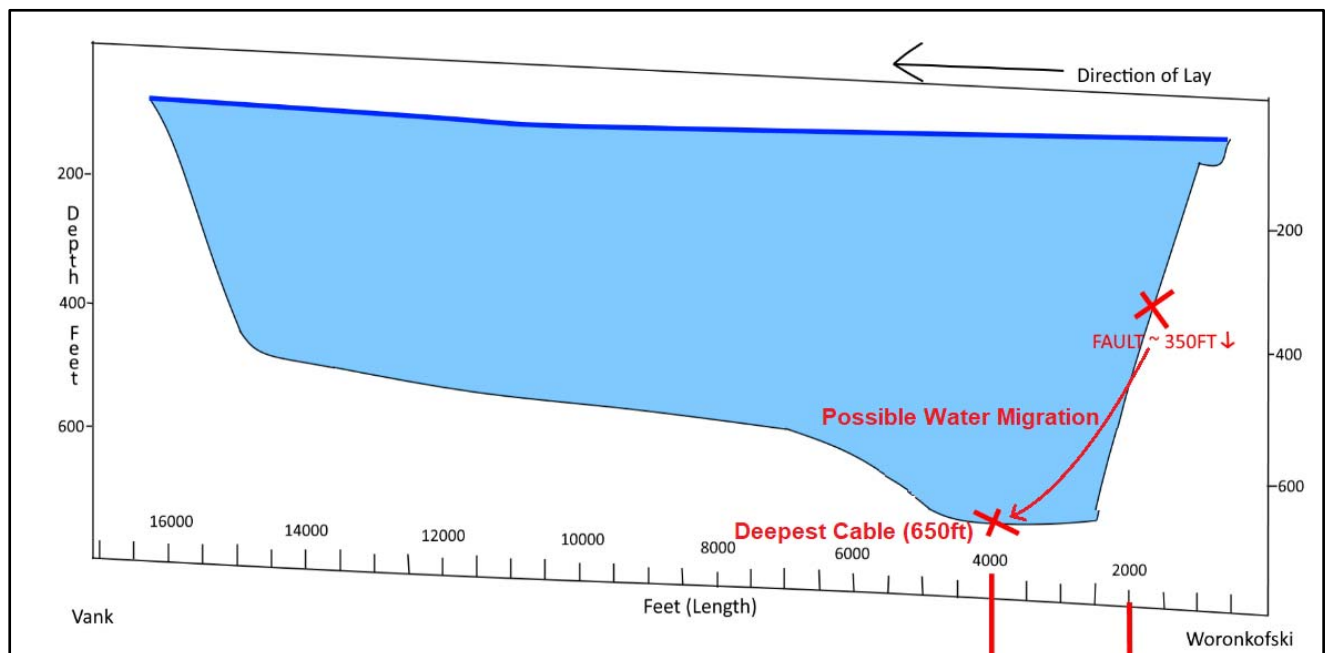
Figure 4: Fault Location vs. Deepest Cable Lay

Determining the length of compromised cable is challenging however there are methods to increase the probability of success. With known densities and pressures at shoreside bellows, a change in pressure over time can be an indication of how much water has entered the cable. As indicated in Figure 4 (below), SEAPA cable consultants have concern with water ingress due to the location of the fault (depth). Because the fault occurred at 350ft depth (2,000ft offshore) and the deepest lay of the cable is at 650ft depth (4,000ft offshore), migration of water from the fault location to the deepest cable lay by diffusion is possible.

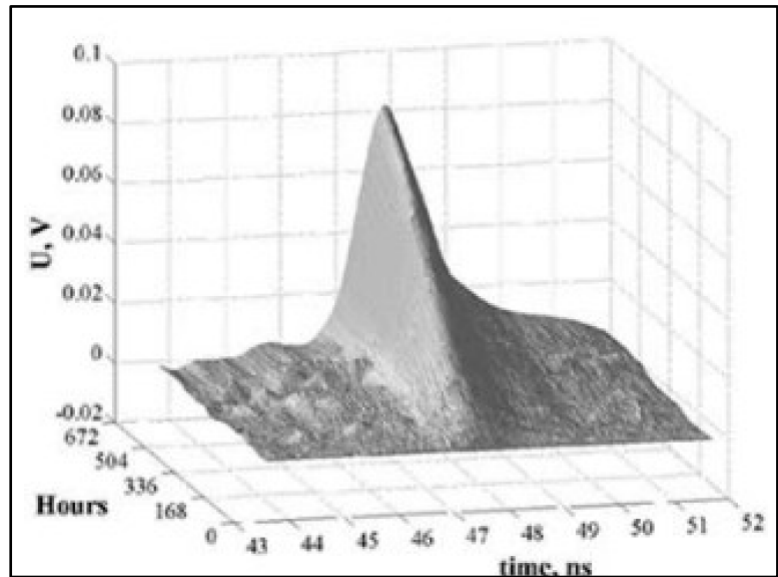
Figure 5: Changes in TDR over time due to Ingress

Another method to determine water ingress is to perform a second TDR test. If water ingress has occurred, changes over time in TDR impulse readings could identify how far down the cable water migration has occurred. Figure 5 illustrates documented TDR test results changing as a function of time as water migration occurs. Considering the initial TDR test occurred on October 9, enough time has now passed to give accurate readings to compare changes in results and determine whether water ingress (if any) has occurred.

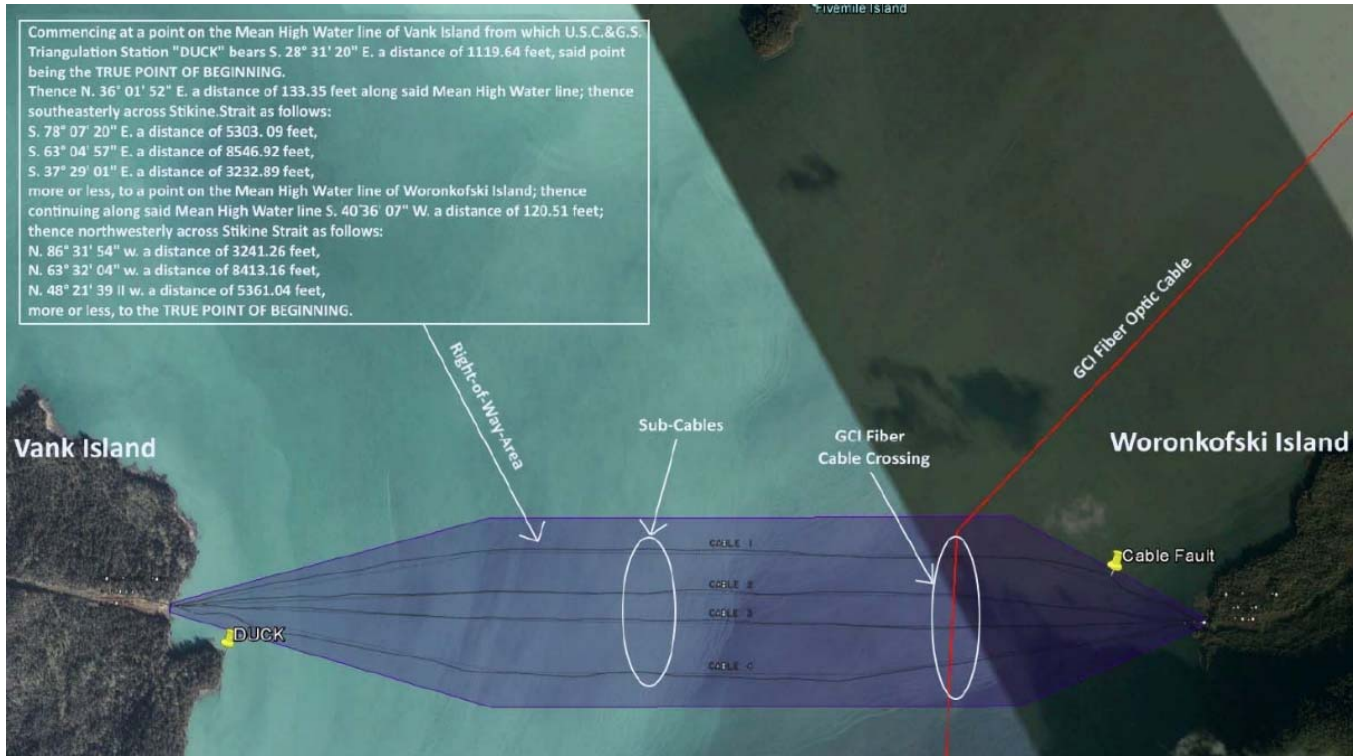
Figure 6: SEAPA Stikine Crossing Easement overlay w/ GCI

SEAPA has an easement with the Department of Natural Resources (DNR) dating back to 1985. In 2017, GCI attained an easement that crosses SEAPA's submarine cables (Figure 6). SEAPA council drafted a notice about easements to GCI for awareness and coordination.
